## TPLO COMPLICATIONS, HOW TO TREAT AND AVOID

Brian S. Beale DVM, DACVS, ACVS Fellow MIS-Ortho  
H-Town Veterinary Specialists  
3015 S. Main ST, Stafford, TX 77477

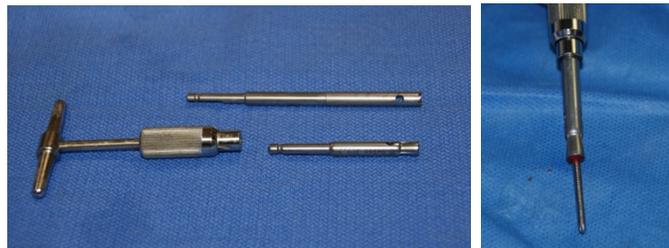
**The screw extraction set can be used to remove broken or stripped screws**

the bone is of poor quality or poor technique was used during screw application. Several options can be considered to try and solve this problem; the screw may be replaced with a larger diameter screw (replace a stripped 3.5 mm screw with a 4.0 cancellous screw), the screw may be placed at a different angle, a locking screw may be used if using a Synthes LCP, the plate may be repositioned, the tibial segment may be left with only two screws for stabilization, or adjunctive stabilization may be supplied ( pin, lag screw or second plate).

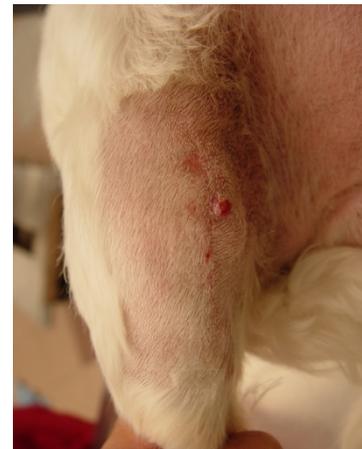
**Incisional infections usually require future implant removal for complete resolution.**

the surgical site may be indicated at the same time. The role of supplemental fixation (tension band, load-sharing pins, lag screws, double plates, etc) at the time of TPLO surgery to prevent fixation failure is currently unknown. Patellar tendon swelling, though usually an asymptomatic radiographic finding, can indicate patellar tendonitis and may be a source of chronic lameness. Infection of the incision should be avoided at all costs due to the possible extension of the infection to the bone, resulting in osteomyelitis. Fortunately, the osteotomy site of most patients undergoing TPLO will heal in the face of an infection, but in some cases infection can result in delayed or non-union. Typically the osteotomy site will have sufficient stability 2 months postoperatively, and removal of the implants at this time will usually result in continued stability and resolution of infection. The necessity for implant removal is much likely if an incisional infection occurs. Recurrent infections have less than a 10% chance of resolution with antibiotic therapy alone. Fortunately, resolution of infections is greater than 95% if the implant is removed, even in the case of highly resistant organisms such as MRSI and MRSA.

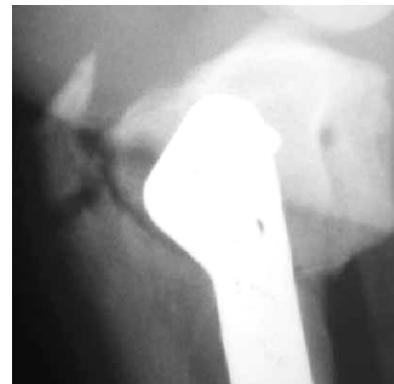
**Tibial tuberosity (TT) fracture can usually be prevented if the fixation pin is placed proximal to the patellar tendon insertion and if adequate TT width is left at the time of TPLO.**

Fracture of the tibial crest is usually the result of an inappropriate osteotomy placed too close to the tibial tuberosity. In addition, placement of the temporary stabilizing K-wire distal to the insertion of the patellar tendon creates a stress riser that weakens the tibial crest. Unless marked displacement occurs, most of these fractures are treated conservatively. Displaced tibial tuberosity fractures are usually successfully treated with a pin and tension band. Fracture of the proximal tibial metaphysis can also occur and appears to occur most commonly early in the healing process. TPLO fixation failure can be the result of acute catastrophic loading of the limb (in excess of osteosynthesis yield strength) or repetitive low energy loading contributing to fatigue failure of the implants or implant loosening. Often,

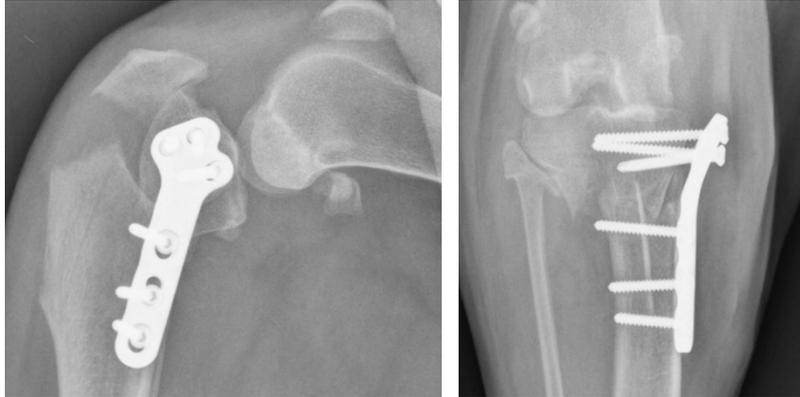
**Severe fractures can rarely occur following TPLO resulting in the need for challenging revision procedures. This patient suffered proximal tibial and tibial tuberosity fractures leading to instability, loss of tibial plateau rotation and implant loosening.**

surgical stabilization with attempts to restore limb alignment and tibial plateau leveling is indicated. Methods that have been used to successfully revise catastrophic fixation failure include placement of a bilateral-uniplanar (type II) external skeletal fixator using the previous jig pin tracts for positioning of the ESF pins, placement of a second bone plate and replacement of the standard 3.5mm TPLO plate with a broad 3.5mm TPLO plate. Removal and/or replacement of the bone plate and/or deep culture of
